# *Texoma Inspections and Testing LLC*

## Property Inspection Report

1234 Any Street, Durant OK, 74701  
Inspection prepared for: John Sample and Jane Doe  
Agent: Renea Roberts - Americam Dream Realty

Inspection Date: 6/25/2013 Time: 12:00 PM  
Age: est. 10 years Size: est. 2198 sf  
Weather: Sunny 92 degrees

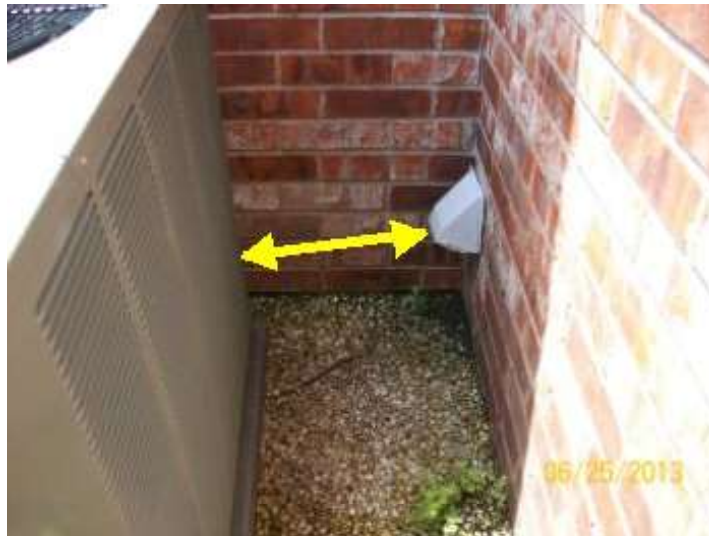
- Appeared functional at the time of inspection.
- Dryer vent within 3 feet of exterior condensor. Dryer vent will clog cooling coils on the a/c unit. Clean often or relocate the location where the vent terminates.

Dryer vent within 3 feet of exterior condensor.

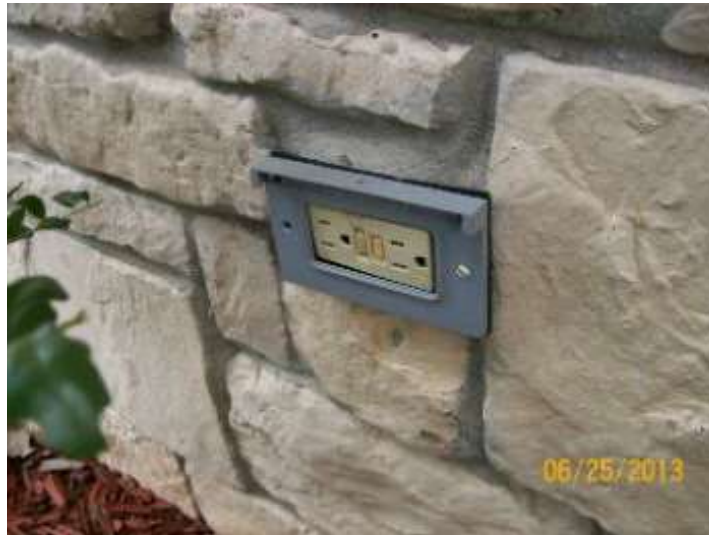
Observations:  
 • Receptacles missing covers on the front and rear of structure.  
 • GFCI Receptacles on the patio and next to the pool pump are trip and will not reset. Need to be replaced.

Receptacles missing covers on the front and rear of structure.

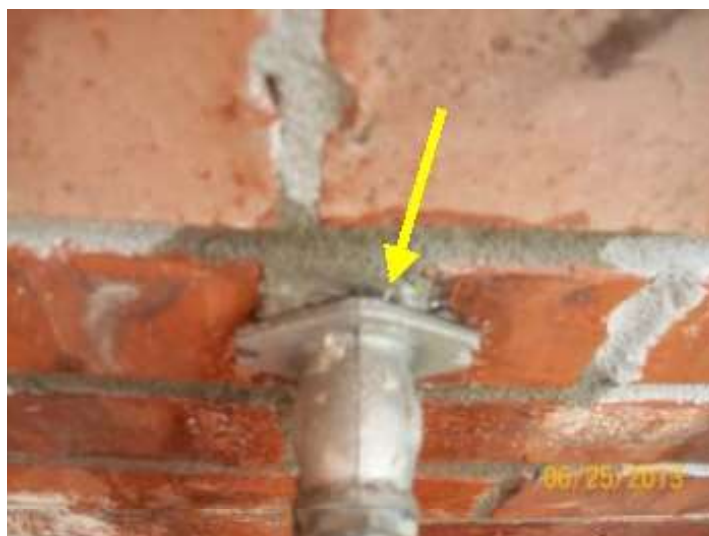
- Rear faucet Appears to be leaking at valve seal when in the open position, recommend repair for water conservation and to prevent possible water damage to structure/water intrusion if the hose is left on for extended period.
- Front west of door Appears Functional.
- **Faucet on front east of door Appears to be damaged/leaking in the wall. Recommend review and repair by a qualified plumber.**

Faucet on front east of door Appears to be damaged/leaking in the wall. Recommend review and repair by a qualified plumber.

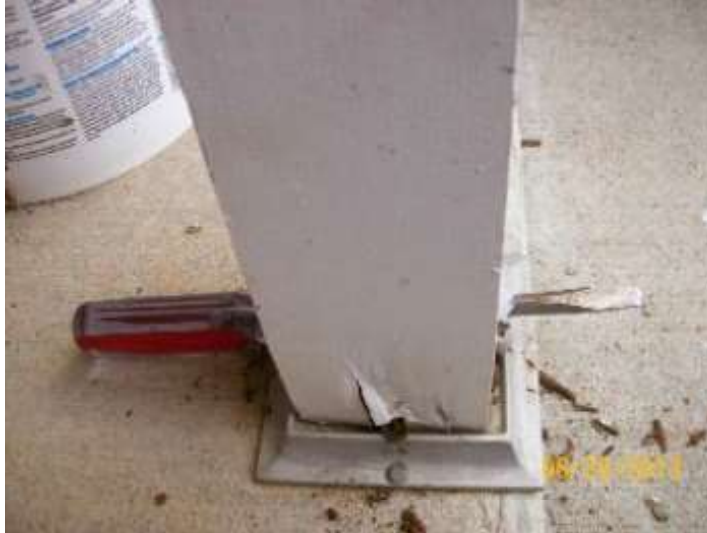
- No major system safety or function concerns noted at time of inspection.
- Support post on the rear of the structure in rotten on the bottom.

Support post on the rear of the structure in rotten on the bottom.
